Healthy and Energy-efficient Living in Traditional Rural Houses

Biodegradation of structures and materials

Urve Kallavus

Tallinn 2012

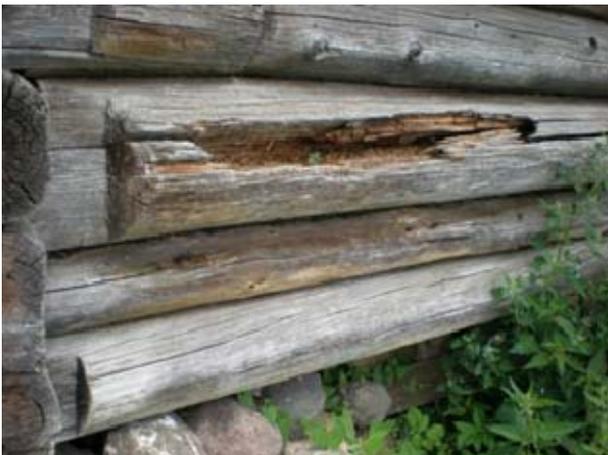
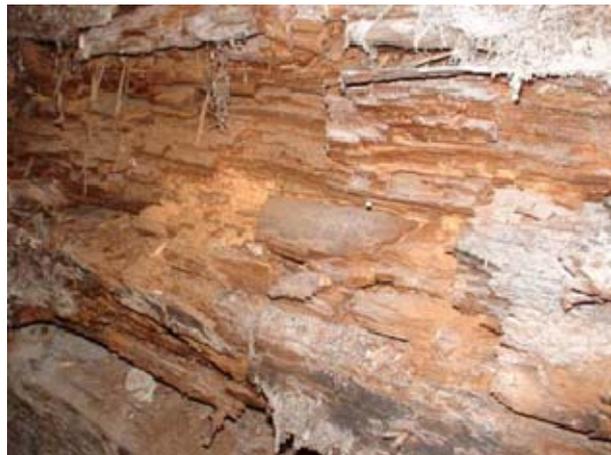
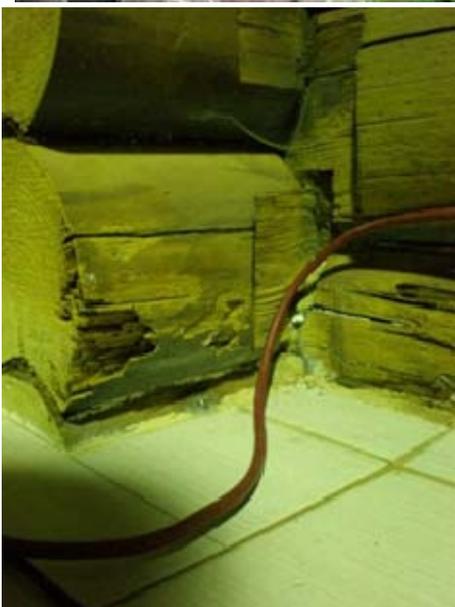
Brown rot can appear everywhere in a house. In typical brown rot appearances are presented in Figure 3. 1. The main amount of water comes from the non-insulated foundation (in this case the rock is not limestone but granite pieces) or from the rainwater what pours onto the beam surface. The distance of the first row of beams is about 10-30 cm from the ground. Frequently in rarely used houses the grass grows higher than the level of the first row of beams and promotes the collection of water in this area. Frequently brown rot is accompanied by insect damage. If in the course of restoration the lower beams are left inside concrete floors, different kinds of rot may appear, but mostly in these cases the brown (dry) rot appears.

Figure 3. 1 Evidence of brown rot outside and inside of beams.

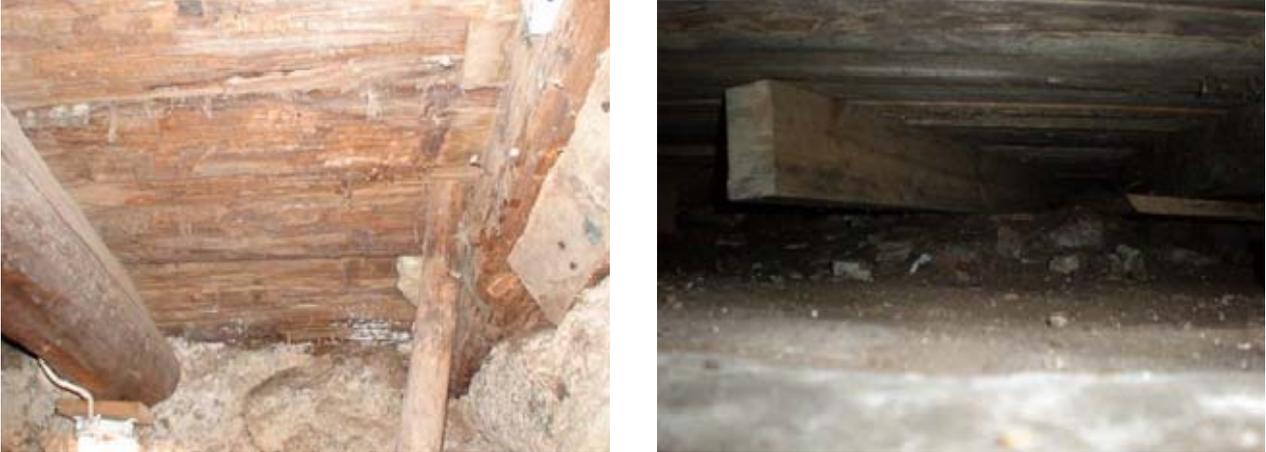
White rot indicates the water leakage spots in the house. In Figure 3. 2 typical white rot attacks are presented.

Figure 3. 2 White rot appearance in different constructional sites.

White rot can appear also in all sites, depending only from the availability of water. Because of that the distribution area of white rot is tightly connected to the water source and can be used as an indication of leaking spots. When the inserted sealing between the ground floor and attic is in direct contact of massive stonewall the water condensation causes appearance of the white rot. Also when the floor beards are too close to the ground or in direct contact with it the growth of white rot is promoted.

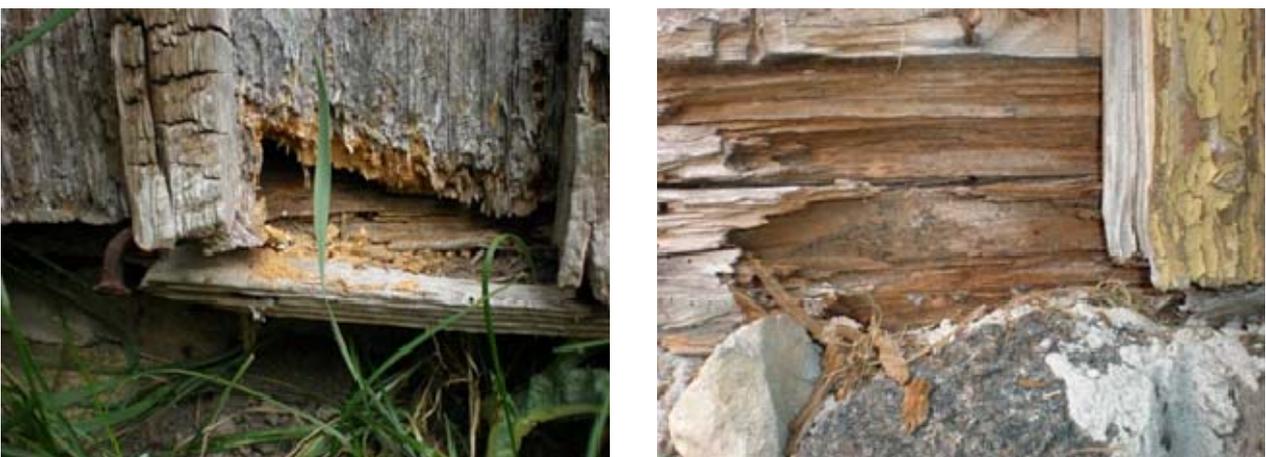
Soft rot requires permanent contact with water. Therefore it could be found mostly in external facade elements. Typical evidences of the soft rot are shown in Figure 3. 3. Soft rot is always an indicator of a poor maintenance.

Figure 3. 3 Evidence of soft rot.

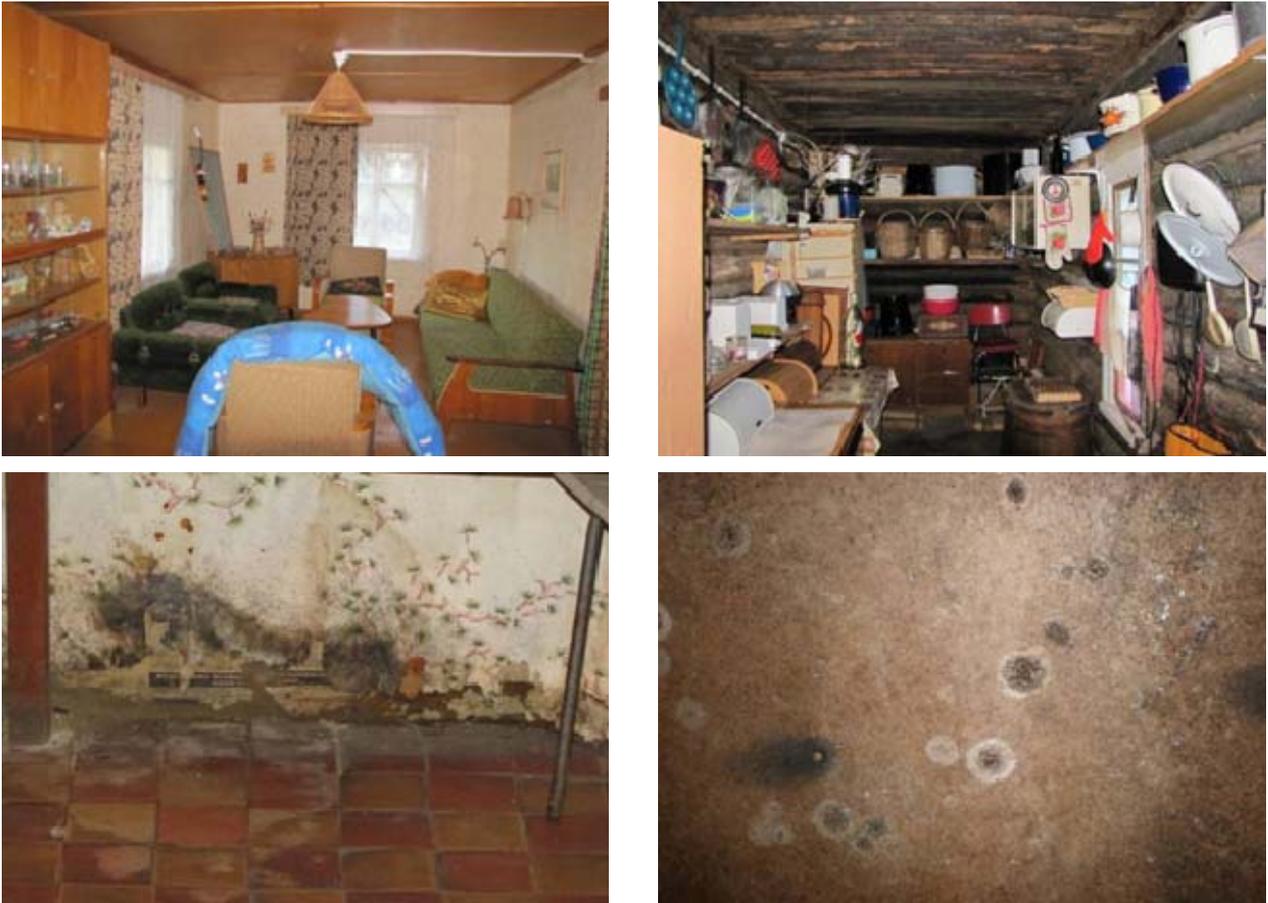
In the appearance of moulds on different materials is shown. Textiles in rarely used summerhouse type rural houses are the most vulnerable to the mould. In storerooms where air is not moving but a quantity of organic food and materials are present, the mould is a common visitor. Wallpaper is the first victim of the moist indoor climate and will be covered extensively with mould.

Figure 3. 4 Mould appearance on different materials.

It is evident that appearance of mould is closely connected to the quality of indoor climate. Therefore before building up the sequence for the eradication of mould from the surface of materials, a survey on the relative humidity, temperature and air movement in indoor atmosphere should be conducted to obtain productive results of the cleaning.

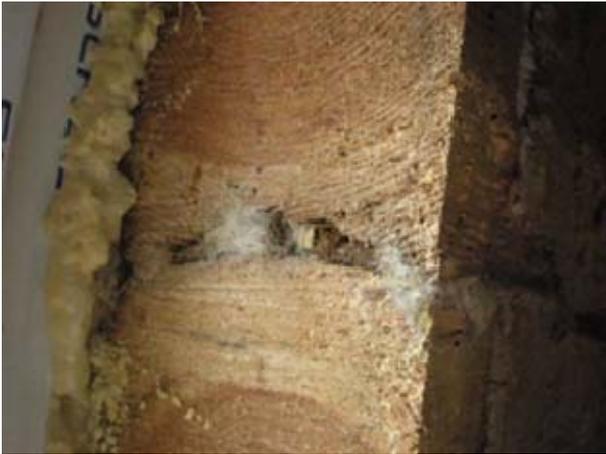
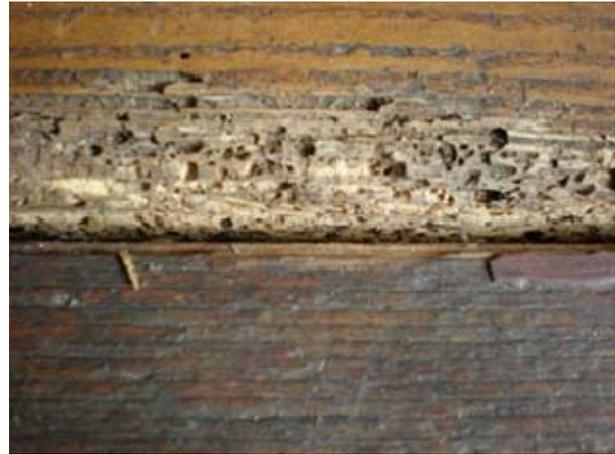
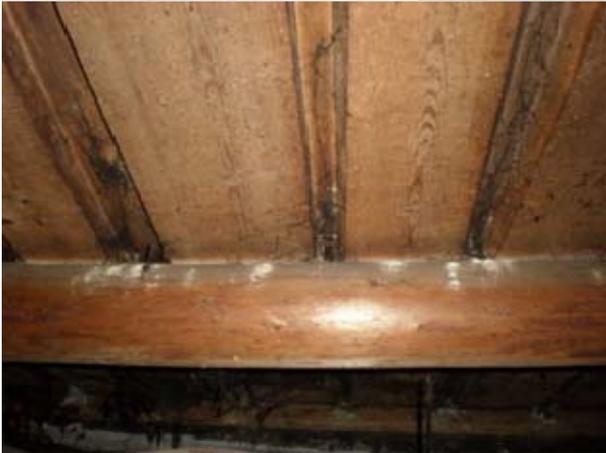
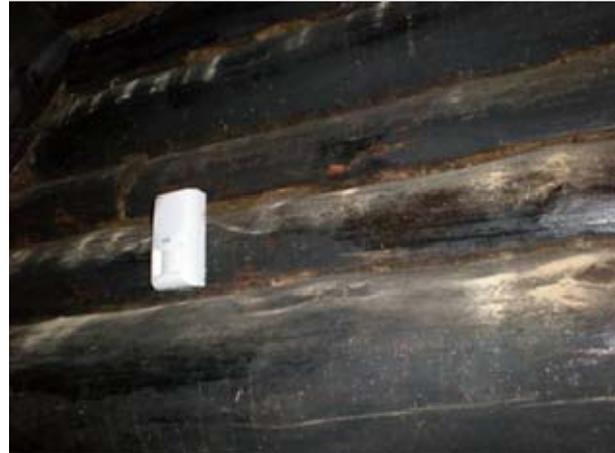
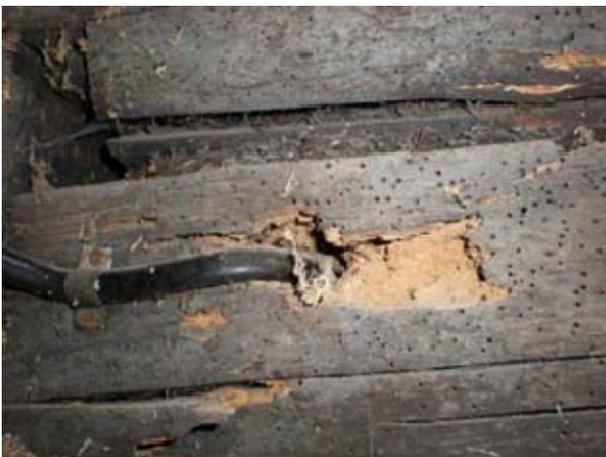
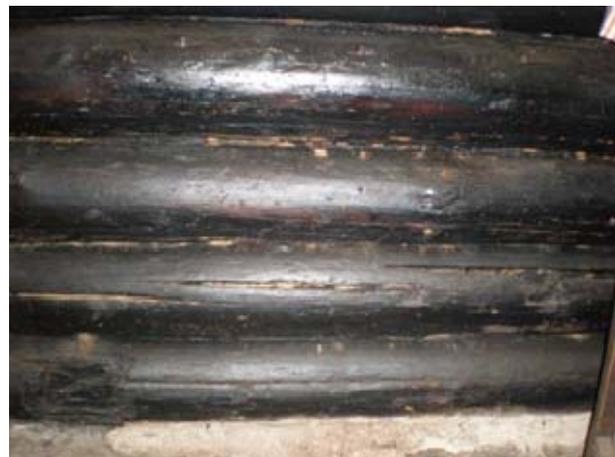
In this survey the main findings were damages by *Anobium* and *Hylotrupes* insects as it is shown in following Figure 3. 5 .

Figure 3. 5 Insect damage of wood.

Wood boring insects affect mainly the sapwood part of the wood stem. In beams used in old wooden houses the share of sapwood in the cross-section area of the stem is minor and therefore the mass and volume loss relatively small. It is visible on beam ends and floor boards as well. Finishing old beams with varnish or paint enhances drastically the activity of the insect. As the finish on the wood surface keeps moisture locked inside the beams, the life cycle of insect turns shorter and more exit holes appear on the surface of wood.

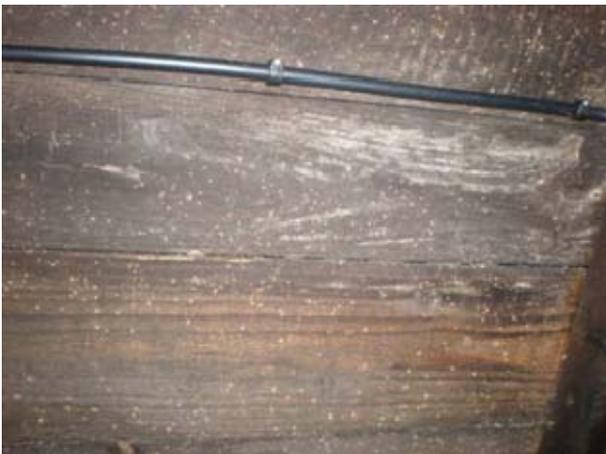
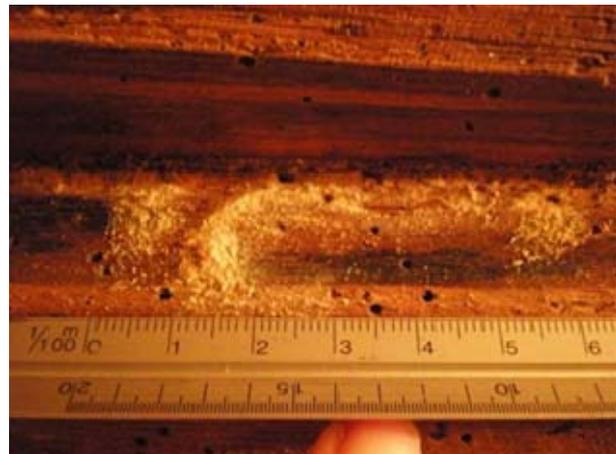
ANOBIUM PUNCTATUM is a pest of major economic importance. The significance of which is not adequately recognized. 3 - 5mm long, dark-brown/black in colour, it is clearly identifiable with the hooded prothorax which covers the head 2 - 3 years spending tunnelling away inside the wood as a larvae the adult beetles will exit via a round hole 1 - 2mm in diameter.

Figure 3. 6 Anobium damage in the wood.

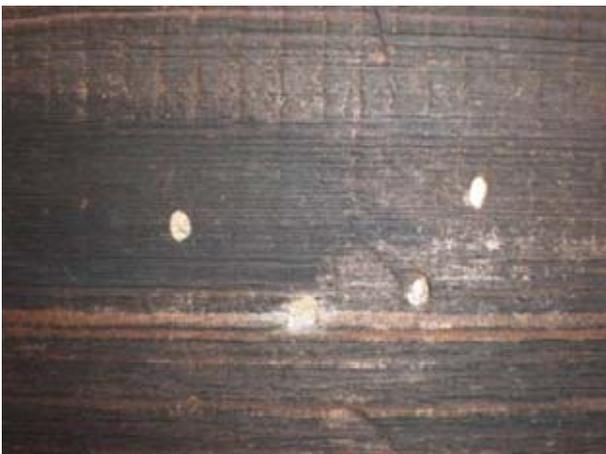
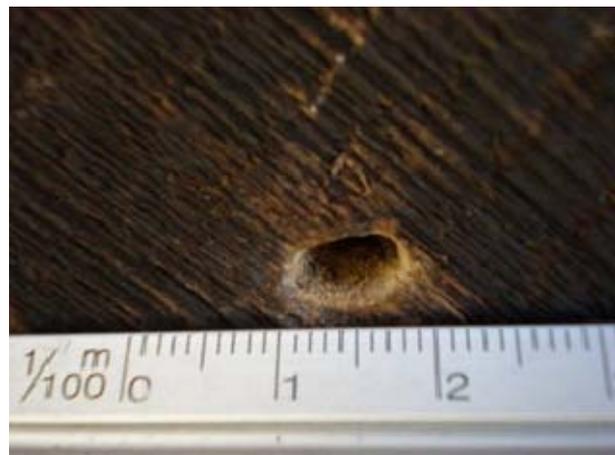
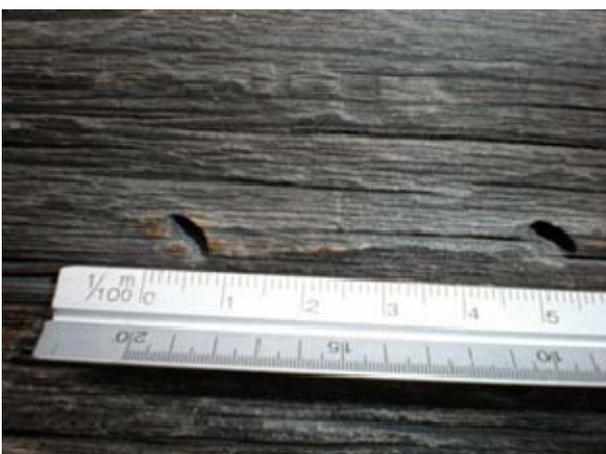
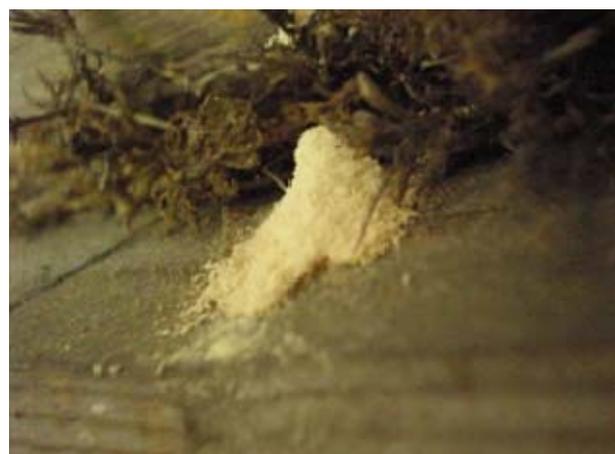
Boring dust is pushed out of holes in the wood and is good evidence of their activity. Large oval holes (6x9 mm) are also a sign of the infestation (http://en.wikipedia.org/wiki/Old-house_borer).

In this study exiting holes with fresh wood powder were found in several cases, particularly in houses recently repaired. The eradication of insects was usually not performed in studied houses (Figure 3. 7).

Figure 3. 7 Evidence of HYLOTRUPES BAJULUS attack.

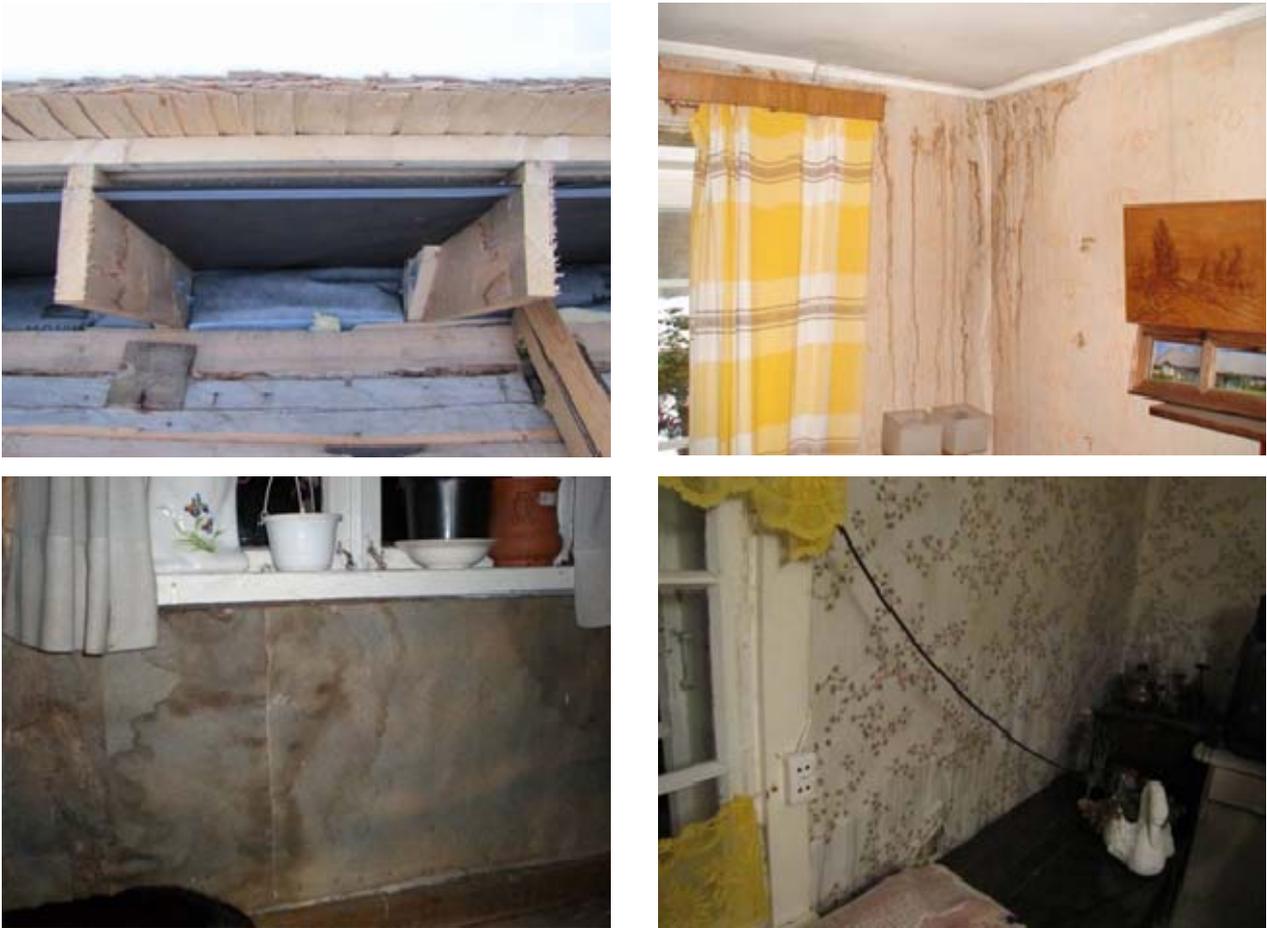
Long before wood rot appears the evidence of „moisture damage“ show up in the form of changes in materials outlook and physical properties. Moisture signs (Figure 3. 8) or construction faults are visible what lead to the moisture problems in the future. When moisture signs appear on internal walls, a real damage is hidden behind the surface. Moisture problems prepare the infestation of biological organisms. Frequent reasons of the moisture damages are maintenance problems and seasonal usage of houses.

Figure 3. 8 Signs of moisture damage in buildings.

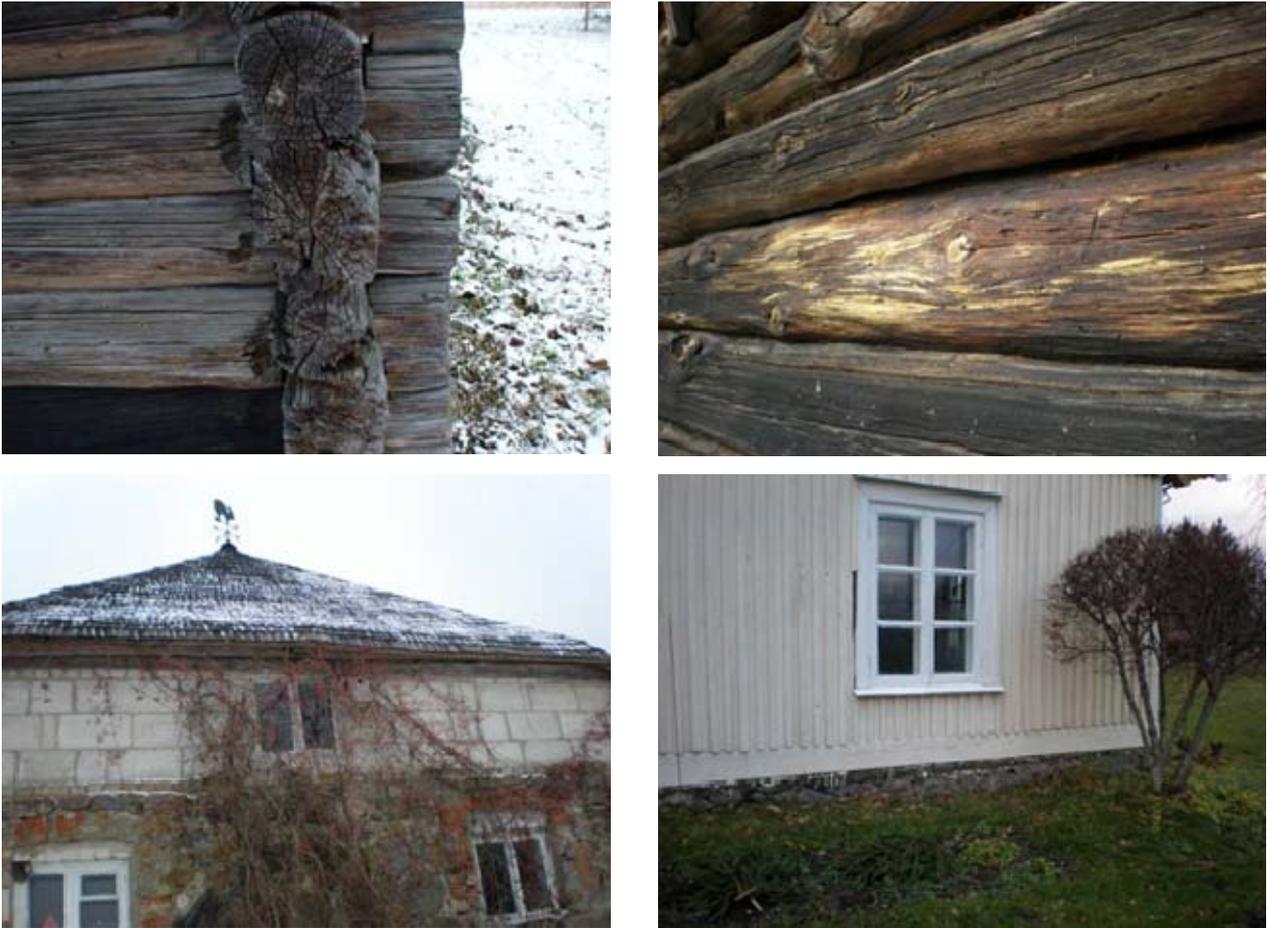
With time a physical ageing of wood in environment occurs. Rural houses were commonly not painted and environmental influences – temperature, wind, light – had strong influence onto the wood surface. It caused volume degradation, extraction of wood tar to the surface etc. (Figure 3. 9). Creeping plants are not right solution for the decoration walls in Northern climate. Also planting too close to the foundation of the house could lead towards degradation of foundation.

Figure 3. 9 Different kinds of problems causing damage which could lead finally to the moisture problems.
